Restoring history

Wagner Roofing repairs Jewett House's tile roof system

Project name: Jewett House

Roof system type: Clay tile and EPDM

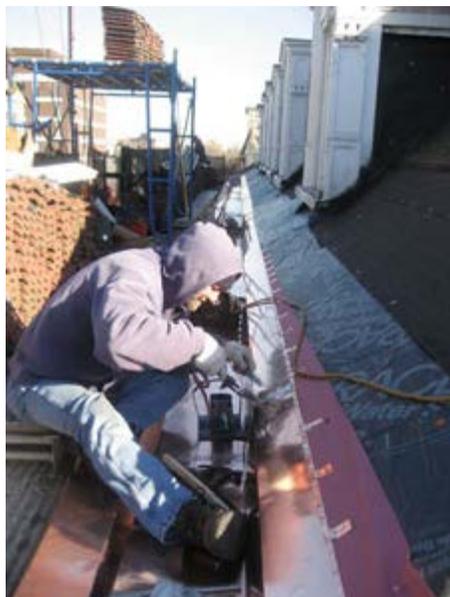
Wagner Roofing employee Randy Herald solders the built-in gutter

Wagner Roofing scraped, repaired and painted all existing metal and wood surfaces, including a decorative cornice below the gutter and decorative galvanized iron metal trim on the dormers. The 16-ounce copper built-in gutters were replaced with 20-ounce copper built-in gutters. All seams were soldered, and expansion joints were installed in between outlets.

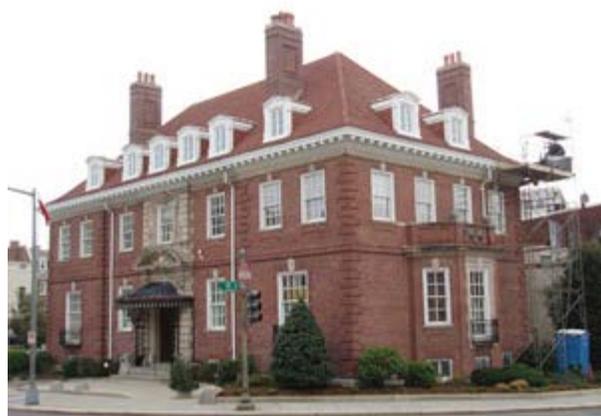
Jewett House's finished clay tile roof system

"We began with replacing the clay tile roof, 14 dormers and copper built-in gutters," says Lee Simon, Wagner Roofing's estimator. "All existing tile that was still in good shape was salvaged for reinstallation. What was not salvageable was replaced with weathered Ludowici French interlocking tiles to match."

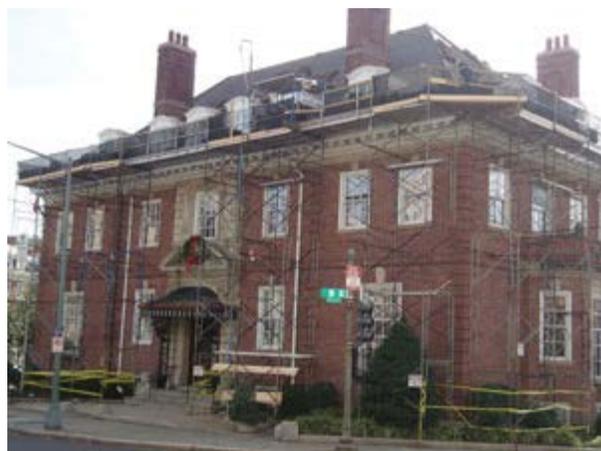
The entire building had to be scaffolded with safety netting below the walkboards and on the safety railings.

"Because of Jewett House's high-profile location at a crowded intersection, the entire building had to be scaffolded with safety netting below the walkboards and on the safety railings," says Chuck Wagner, Wagner Roofing's president. "Where the scaffold extended over the sidewalk, a pedestrian tunnel was erected."
